USAAEFA PROJECT NO. 77-33

**PRELIMINARY AIRWORTHINESS EVALUATION
AH-1S HELICOPTER EQUIPPED WITH A
GARRETT INFRARED RADIATION SUPPRESSOR
AND AN/ALQ-144 JAMMER**

FINAL REPORT

MAY 1978

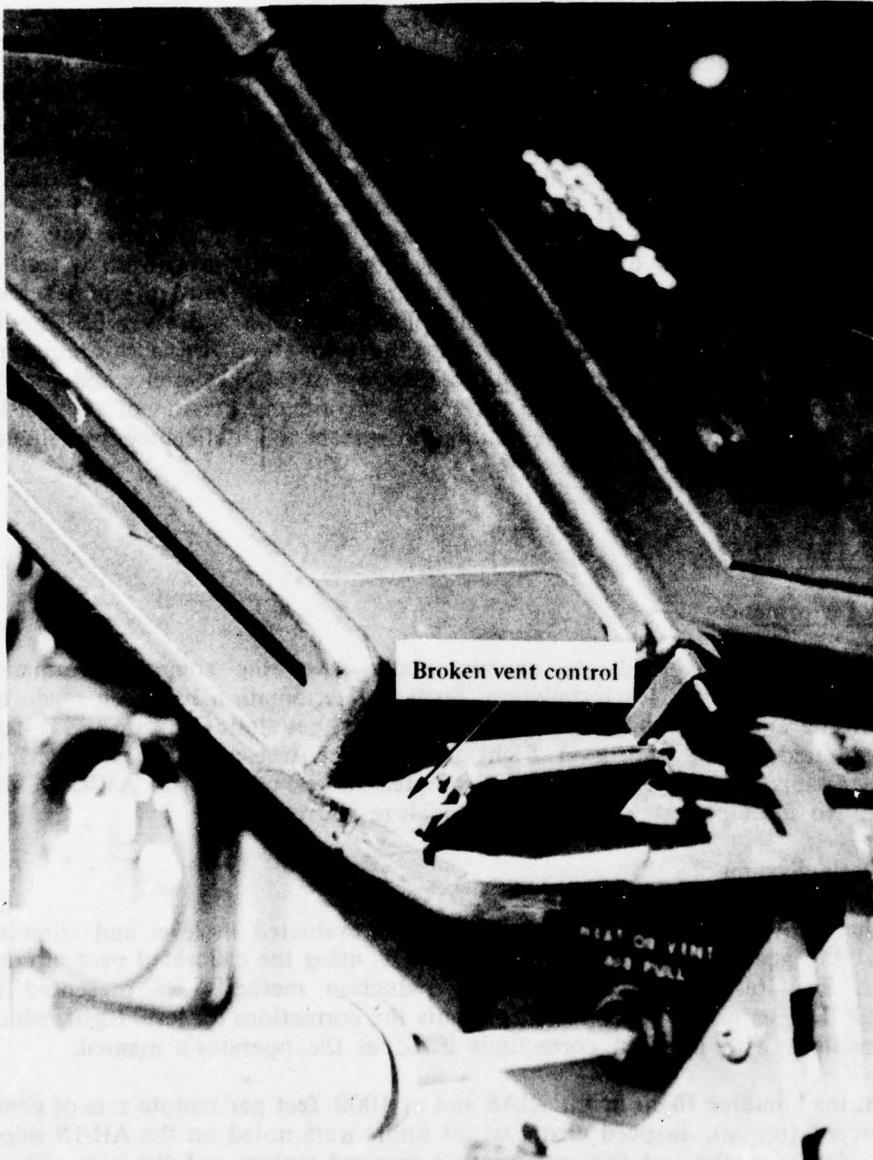
Photo C. Pilot Right-Hand Vent Control.

32. The pilot station ventilation system on the production AH-1S consists of a main vent control knob and two rectangular vent outlets located on the left and right sides of the instrument console. This ventilation system is different from the AH-1G system. Vent outlets are nonadjustable, having fixed vanes which direct airflow to the pilot's face and chest. Separate on/off vent controls are provided at each outlet, but are poorly designed and easily damaged, as evidenced by the broken right side control on the test aircraft (photo C). When hovering over unprepared surfaces, the dust and dirt raised by the rotor downwash is readily ingested into the aircraft vent system and forcibly ejected onto the pilot's face and chest. Even with a properly fitted helmet and with the visor full down, sufficient dust and dirt can be blown into the pilot's eyes to cause temporary blindness and eye damage with the potential for loss of visual reference and aircraft damage. Operation from unprepared surfaces is an integral portion of the AH-1S mission. The present nonadjustable ventilation system is a deficiency and should be modified as soon as possible.

2. The deficiency listed in paragraph 40 has been corrected by the addition of adjustable air vents starting with the #67 Production AH-1S, S/N 77-22729.
